Inspection Report

Sample Report

999 Sample Ave
Anywhere AR 99999

HomeSpects of Arkansas

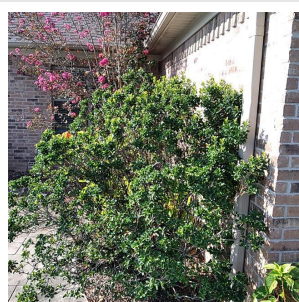
2.2 Item 7 (Picture)

(1) Shrubs and tree limbs should be trimmed away from structure. Ideal recommendation is removal of trees at front corners and rear.

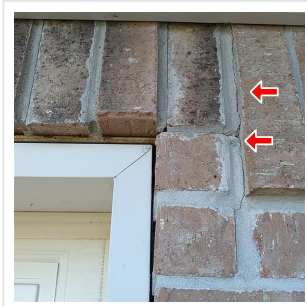
4.0 Item 6 (Picture)

(2) Client should expect to see some slight cracks around garage door lintels. However, the amount movement visible at left front corner of structure is not typical for age of structure. This movement along with the crack in the garage slab is concerning. Recommend a licensed Structural Engineer/Contractor to evaluate.

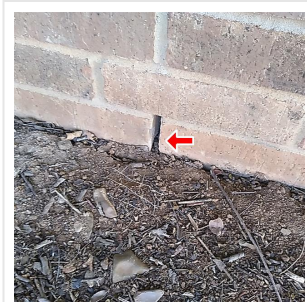
4.0 Item 12 (Picture)

(3) Weep holes should not be below grade. Recommend a licensed Contractor to evaluate and correct.

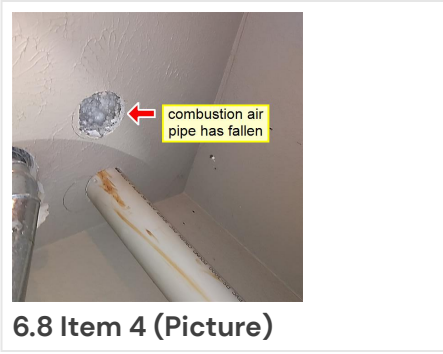
6.8 Item 4 (Picture)

(1) Water heater is a 2004 unit and original to the structure. At the later stages of a typical life expectancy. Signs of rust/leakage at right/cold water nipple. A life safety concern exists at time of inspection as the exhaust flue and draft hood was not installed over the water heater vent allowing carbon monoxide to be dispersed into the garage area. I turned the water heater thermostat to "vacation" to keep the unit from operating. There was also some water staining visible on the water heater stand indicating possible leakage from the tank. There was no emergency drain pan installed. Installation is recommended. The full recommendation is installation of a new water heater via current code by a licensed Plumber along with making sure venting to the exterior is proper along with securing the combustion air pipes (one has fallen onto the floor).

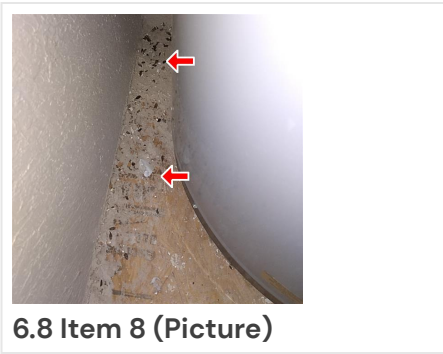
6.8 Item 8 (Picture)

(2) Rodent signs. Recommend establishing a contract with a licensed Exterminator.

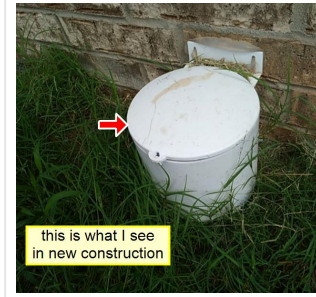
11.9 Item 3 (Picture)

(1) Dryer vent near grade. Appears area may have been dug out and vent possibly could have been below grade at one time. Recommend installation of vent extension pictured. These are installed in new construction when needed and helps vents that are in danger of water intrusion.
