Summary Only

Property Address:

999 Sample Rd
Cabot AR 72023

GENERAL SUMMARY

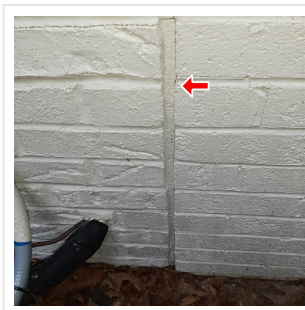
3.0 Item 11 (Picture)

(2) Expansion gap where addition meets original structure. This area will have differential settlement due to two separate footings. This crack is long and has got some visible width toward the top. The Contractor may as well assess this area while he is at the property to look in the crawlspace.

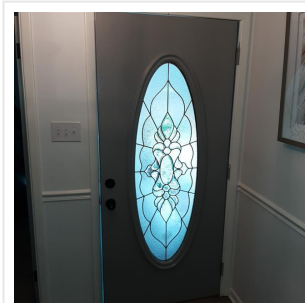
3.6 Item 1 (Picture)

Main entry door hits jamb at top. Deadbolt doesn't want to latch. Hinge side has wide gap towards top. Recommend to sink longer screws into top 2 hinges to pull door that direction.

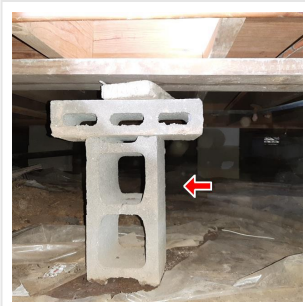
3.9 Item 16 (Picture)

(1) Areas under bathrooms and furnace/evaporator coil area still have signs of damage to subfloor and joists. Less significant issues under the kitchen. Repairs have been made, some unprofessionally. Added piers under the home are suspect and not proper. Areas under utility room have plate and joist rot. Recommend licensed Structural Contractor for further evaluation and quote. Recommend removal of wood debris.

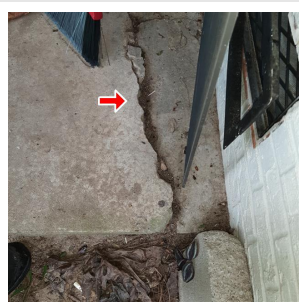
2.4 Item 1 (Picture)

Rear covered patio slab has large cracks. Recommend filling to prevent water intrusion from wind driven rain. Client could also repour slab. Rear addition appears to have built on top of a portion of the sunken slab.

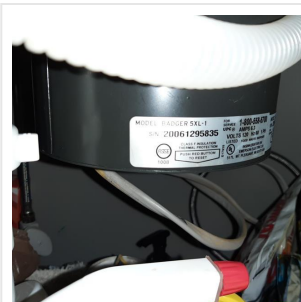
11.1 Item 1 (Picture)

Noisy. Check for items in disposal. If nothing is in disposal, then recommend repair/,replacement.
